Inspection Report Minerals Regulatory Program

Mine Name: Grantsville Quarry Operator Name: Chemical Lime		ber: M04500 Date: April 20 2:40 PM	
Inspector(s): Paul Baker Other Participants: Dave Smith, Chemical Lime Mine Status: Active	Weather: C	lear, 60's	
Elements of Inspection	Evaluated	Comment	Enforcement
 Permits, Revisions, Transfer, Bonds Public Safety (shafts, adits, trash, signs, highwalls) Protection of Drainages / Erosion Control Deleterious Material Roads (maintenance, surfacing, dust control, safety) Concurrent Reclamation Backfilling/Grading (trenches, pits, roads, highwalls, shafts, drill holes) Water Impoundments Soils Revegetation Air Quality Other

M0450028, Grantsville Quarry, Chemical Lime

Inspection Dated: April 20, 2006; Report Dated: May 3, 2006

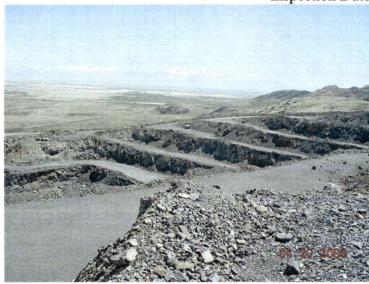
It is Chemical Lime's policy to do as much concurrent reclamation as possible, but that has been difficult at this site because the entire mine is open and subject to mining. Photo 1 shows a large portion of the active mining area.

Photo 1. This shows a large portion of the quarry.

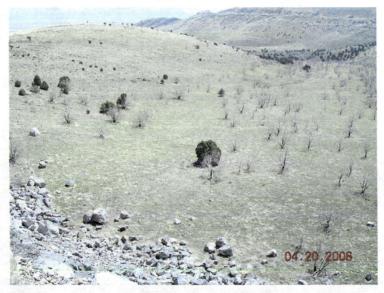
To the south of the mine is a waste pile bordering on a SITLA lease (Photo 2). The lease begins at about the juniper tree at the center of this photo. The operator intends to push down the waste pile to the edge of the lease area and complete reclamation in this area. Although the operator would like to open the state lease for mining, they have been unable to complete an agreement with the surface owner.

Photo 2. Looking approximately south or southeast from the top of a waste rock pile. Beyond the juniper in the center of the photo is the SITLA lease.

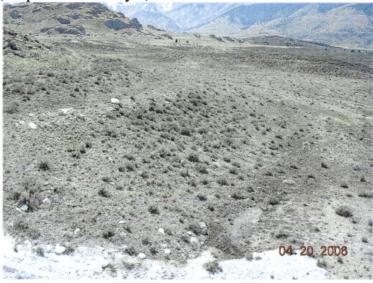
The operator has a variance from soil salvage requirements, but there are a few places where it appears soil may be available. At the bottom of the hill west of the westernmost dump, it looks like there should be some salvageable soil (Photo 3).

Photo 3. This is looking toward the base of a waste rock pile west of the mine and plant. If this pile is expanded, there may be soils that could be salvaged.

Although the plan contains a variance from soil salvage requirements, I suggest that the operator attempt to salvage soil when it is feasible and desirable. Soils containing noxious weeds or excess salts should not be salvaged.

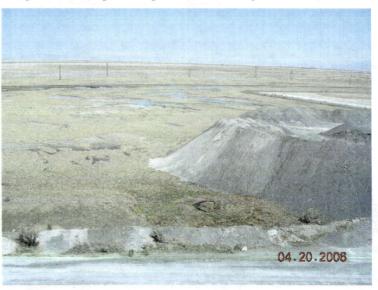
Photo 4 shows a dump the operator is no longer expanding because it was affecting a wetland.

Photo 4. A waste rock pile, no longer being expanded, that was encroaching on a wetland.
